FINAL REPORT OF MINE EXPLOSION  
THREE POINT MINE  
THREE POINT COAL CORPORATION  
THREE POINT, HARLAND COUNTY, KENTUCKY

September 16, 1943

Charles M. Keenan  
Coal Mine Inspector

UNITED STATES  
DEPARTMENT OF INTERIOR  
BUREAU OF MINES

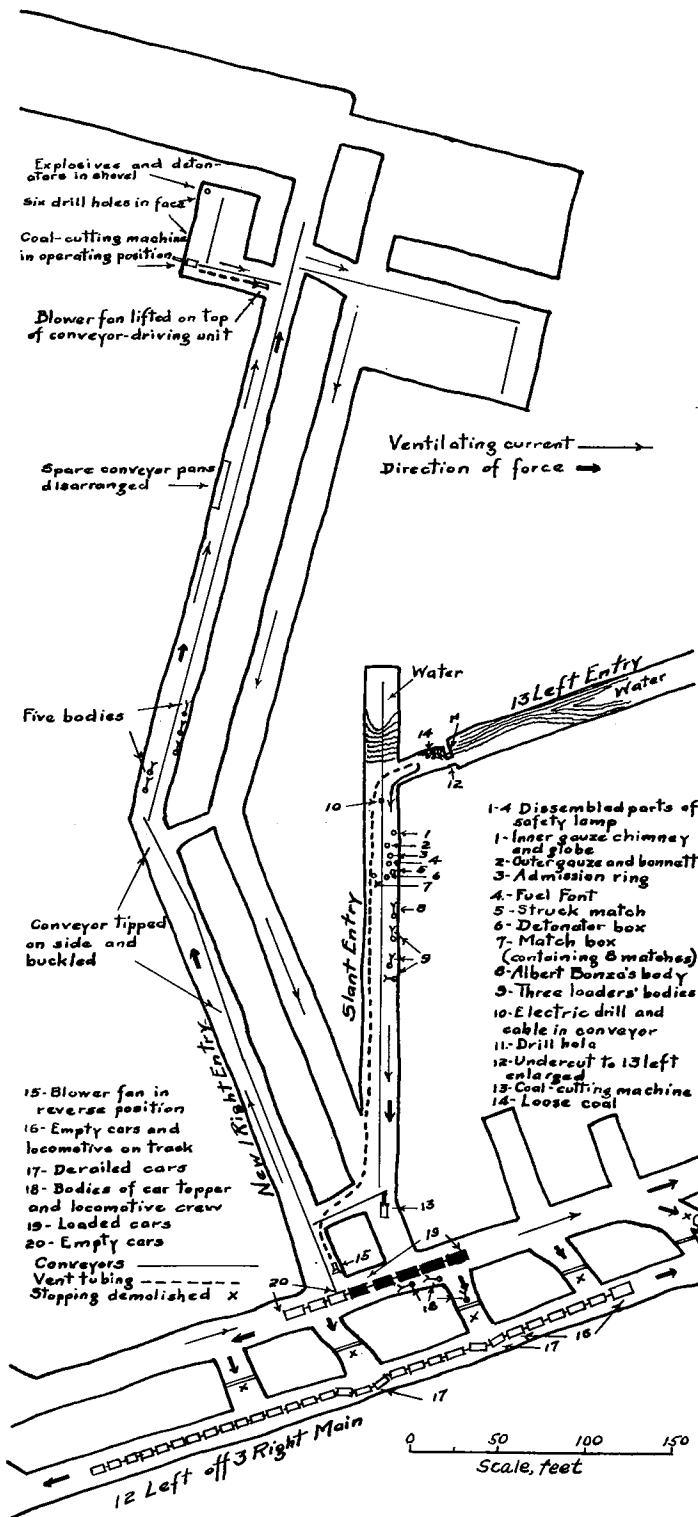
DETAIL MAP OF EXPLOSION AREA  
 NEW RIGHT ENTRY OFF 12 LEFT 3 NORTH  
 THREE POINT MINE

The forces of the explosion seemed to radiate from the slant entry off new 1 right, and all destroyed stoppings were blown outward toward the entry. The wood from the door frames inby the curve on 12 left was blown outward, but the broken doors were lying inby, or on the air-course side of, the door frames; these doors, apparently blown open by the blast, were broken when they were slammed shut by the retonation wave. A trip of 29 empty cars, coupled to the locomotive, was standing on 12 left entry directly inby the turn-out to the new 1 right loading head. The sixth and seventh, and the twelfth, thirteenth, and fourteenth cars in the trip were derailed to the side of the track away from the air course; these cars were directly in front of the crosscuts which were nearest in line with the new 1 right air course and entry, respectively. The locomotive trolley pole was still in contact with the trolley wire, but the top covers on the locomotive were disarranged, and two sections were lying on the floor of the entry.

Since only small percentages of methane were found at any place in the affected area with an electric methane tester, it can be assumed that gas, which had accumulated in the face of the idle 13 left entry, had seeped into the slant entry through either the drill hole or the undercut connection that had been made between the face of the crosscut from the slant entry and the face of 13 left entry. It is highly probable that the flame safety lamp had been extinguished by the mixture of methane and air in the vicinity of the crosscut, and, from the location of the bodies, the official had taken the men with him to a point about 50 feet outby the crosscut to relight the safety lamp. Other sources of ignition were not discernible.
